Manhole Inspection Summary

Manhole # S15AA_025MH

Insp Date: **5/6/09 3:24 PM**

Location Address: **1117 ASHBURTON ST**

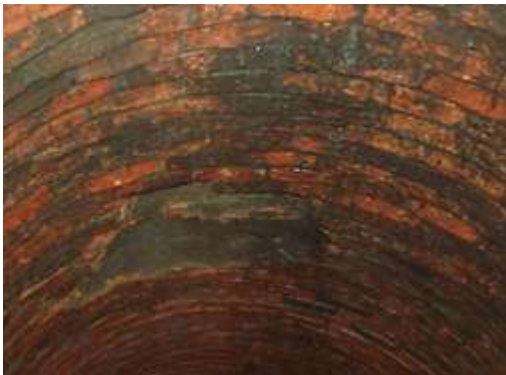
Defect 3

Condition: ☐ Sound ☒ **Cracked** ☐ Root Intrusion ☒ **Loose Brick** ☐ Deteriorated

LOOSE CORBEL BRICK

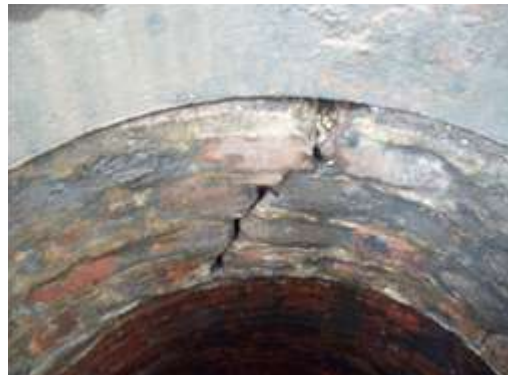
Defect 2

CRACKED CORBEL

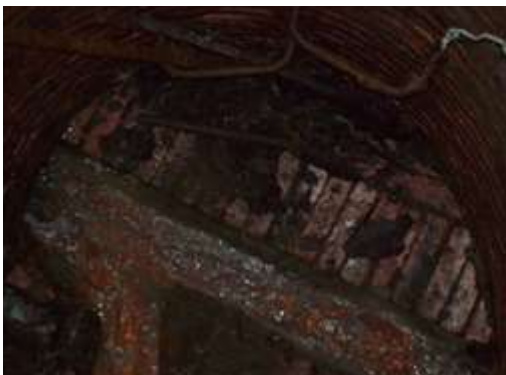
Defect 1

Condition: ☐ Sound ☐ Cracked ☐ Root Intrusion ☐ Deteriorated ☐ Leaks ☒ **Debris**

DEBRIS ON BENCH AND CHANNEL

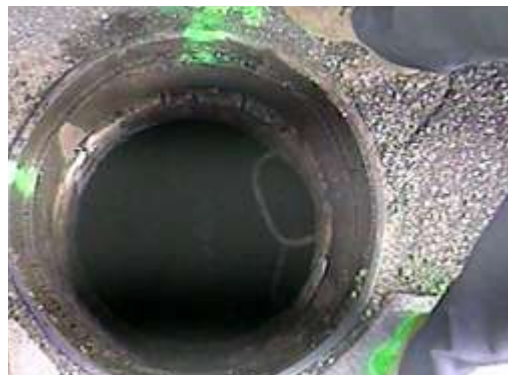
Defect 4

Frame Offset: **1** (in.) Condition: ☒ Sound ☐ Cracked ☐ Leaks

FRAME OFFSET

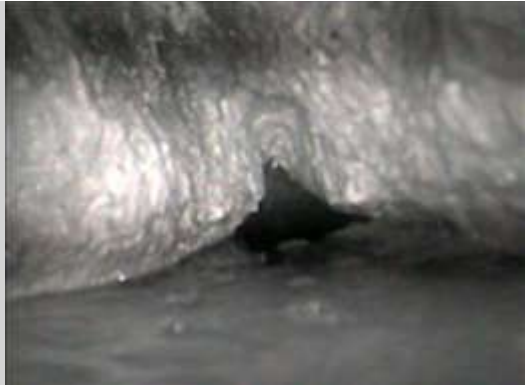
12 O'Clock Outflow

8 in. Circular Gravity Sewer
Pipe Out @ 12 O'Clock

Invert Depth: **12.42** (ft.) Flow Characteristics: **Slow**

Deposits: ☐ None ☒ **Mud** ☒ **Gravy** ☒ **Debris** ☒ **Grease**

Silt Depth: **2** (in.) Deposits Extent: **Medium**

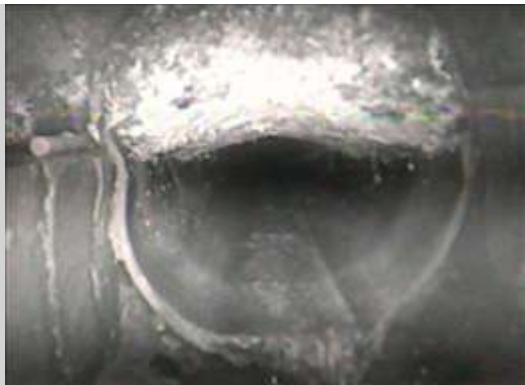
6 O'Clock Inflow

8 in. Circular Gravity Sewer
Pipe In @ 6 O'Clock

Invert Depth: **12.22** (ft.) Flow Characteristics: **Slow**

Deposits: ☒ None ☐ **Mud** ☐ **Gravy** ☐ **Debris** ☐ **Grease**

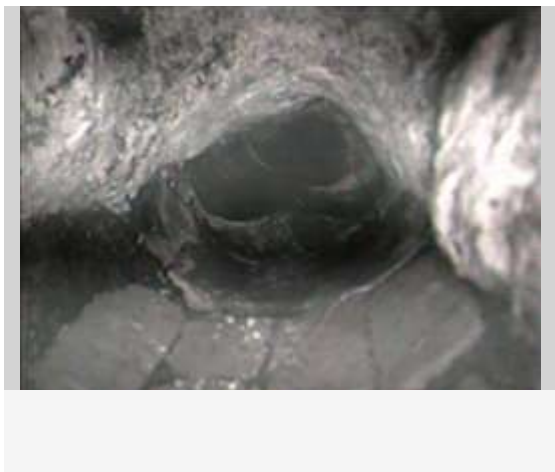
9 O'Clock Inflow

8 in. Circular Gravity Sewer
Pipe In @ 9 O'Clock

Pipe Height: (in.) Direct
Pipe Material: **Clay** ☐ Pipe Lined
Invert Depth: **12.10** (ft.) Flow Characteristics: **Slow**
Deposits: ☐ None ☒ **Mud** ☒ **Sludge** ☐ Debris ☐ Grease
Silt Depth: **0** (in.) Deposits Extent: **Medium**
Infiltration: **None** Pipe Seal Cond: **Sound**
